EVALUATION OF PAVEMENT CONDITION OF RURAL ROADS UNDER PMGSY FOR MAINTENANCE AT PATNA

Suman S.K* and Ajeet KumarYadav

Department of Civil Engineering NIT Patna, Patna-5

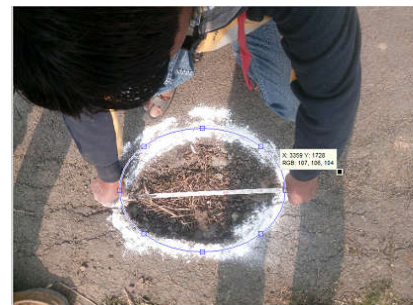
Figure 4 Pothole

Some of the distress involves potholes its measurement in numbers i.e, counting of potholes but levels of severity of potholes depends on the diameter of potholes and depth of the potholes. Since as one of the limitations of this work is that with the help of single still image it is not possible to measure the depth of potholes. The diameter of the potholes can be measured as using the command imellipse. Figure 4 shows to capture the potholes from the image using imellipse.

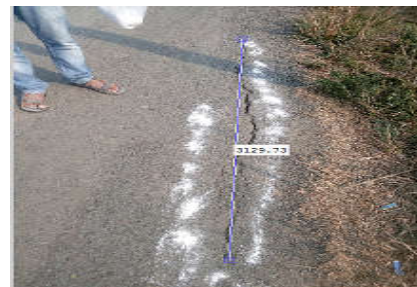
Figure 5 Longitudinal cracking

Linear measurement involves only one dimensional measurement and is used in different types of distresses such as edge cracking, longitudinal cracking, and transverse cracking. This makes use of imtoolfunction which helps to determine the length of edge, long & transverse cracks (Fig 5).

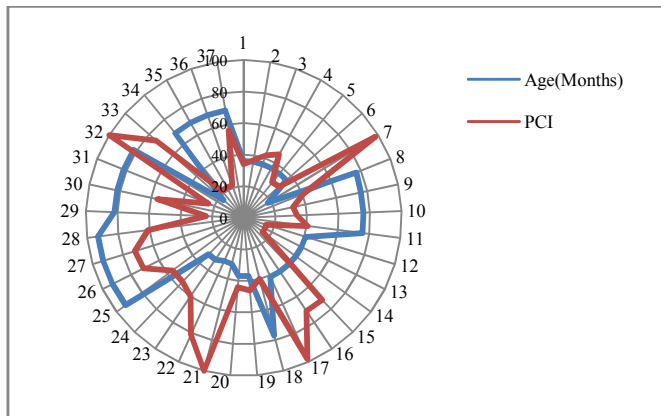
Figure 6 Cotour map for PCI and Age

Pavement conditions rating out of 37km rural roads are represented as 11% of the roads are in excellent condition,22% of the roads are in very good condition,13% roads are in good condition,16% roads are in fair condition,19% roads are in poor condition and 19% roads are in very poor condition as shown in Figure 6. Road wise condition along with age is described in Figure 8. Figure 7 also sows the contour of pavement condition index with age of the pavements. With the help of contour map we can observe the age of the pavement with its condition.

With reference to Figure 6, it has been observed that 67.57% roads have age around 4 years while 32.43% roads have age more than 4 years. About 35% roads are in serviceable condition whose condition is fair or above otherwise below fair condition. The rate of deterioration is very fast, this may be due to the bad quality of materials, degree of workability, and climatic condition of Patna, Bihar. In Bihar average annual rainfall is 1000mm/year and maximum temperature reached in summer is about 40 °C.
