ANTHROPOGENIC ACTIVITIES ON SHORELINE ENVIRONS – A PROFILE OF  
BYRAMANGALA RESERVOIR, KARNATAKA, INDIA

**RESEARCH ARTICLE**

**ANTHROPOGENIC ACTIVITIES ON SHORELINE ENVIRONS – A PROFILE OF  
BYRAMANGALA RESERVOIR, KARNATAKA, INDIA**

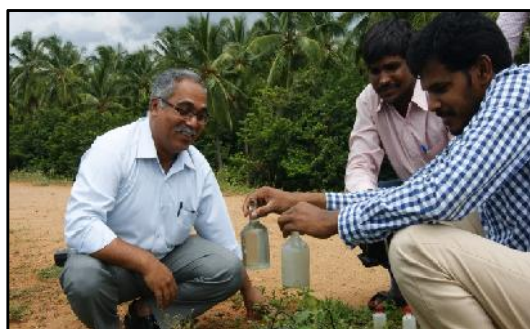
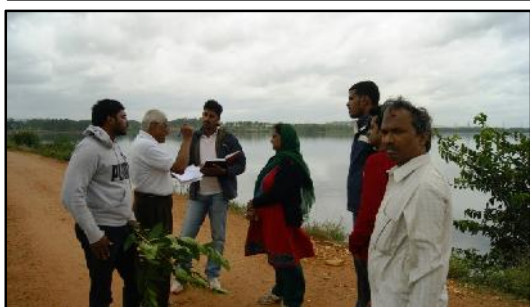
Figure 1&2 Observation and Sample collection of water sample from Byramangala reservoir

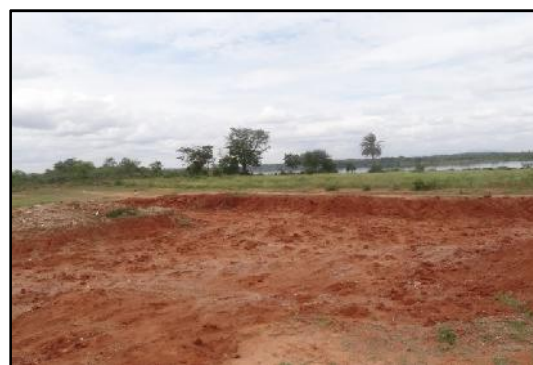
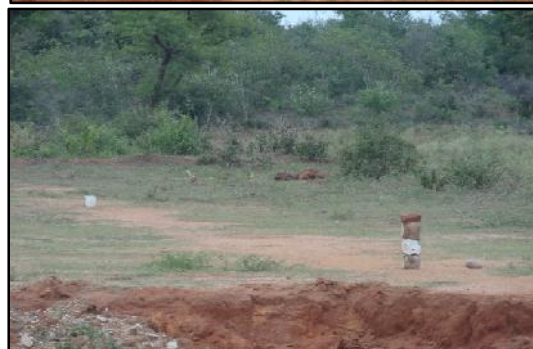
Figure 3&4 Open spaces of reservoir shore used as play ground and soil is removed for brick making

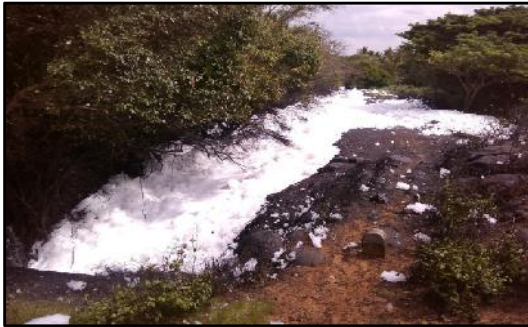
**Foams:** The foam formation near the reservoir out-lets is usually natural. Wind-driven currents frequently create parallel streaks of foam in open water that accumulate along windward shores. Foam is created as decomposing plants and animals release organic compounds into the water. The compounds reduce the surface tension of water, causing bubbles to form. The foam formation in the Byramangala reservoir may be due to detergents and organic matter which are from point source discharges like domestic sewage and industrial effluent.

Minnesota Shore land Management (2014) also facts out shoreline foam on detergents, but detergents do not create long-lasting foam since they quickly lose their lather ability. Industrial pollution effluents may have been a more common source of foam on surface water.

Figure 5 Irrigation canals of the reservoir carrying polluted water and foam

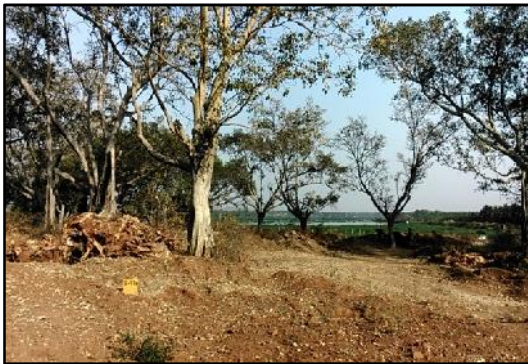
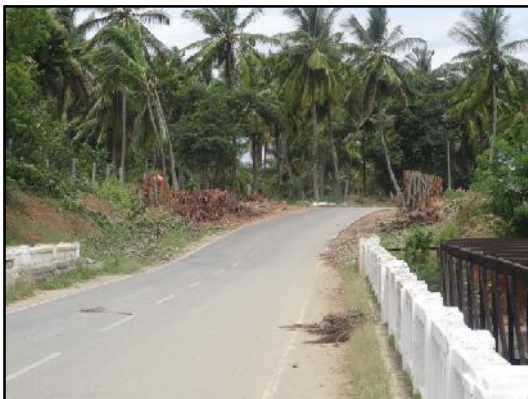
**Uprooting Natural Vegetation:** Natural vegetation is important as it possess protection to stabilization of reservoir Environs. Due to expansion of roads, and expanding agriculture area, uprooting the natural vegetation is increasing around Byramangala reservoir.

Figure 6&7 Uprooting natural vegetation for road expansion near the outlet of Byramangala reservoir

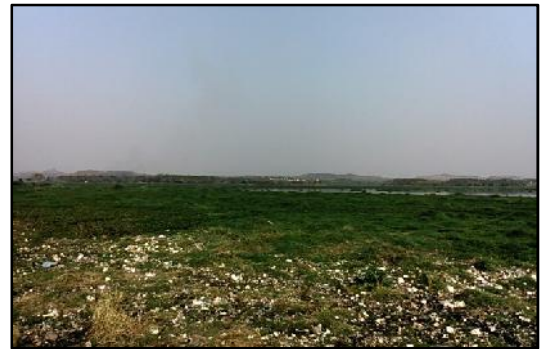
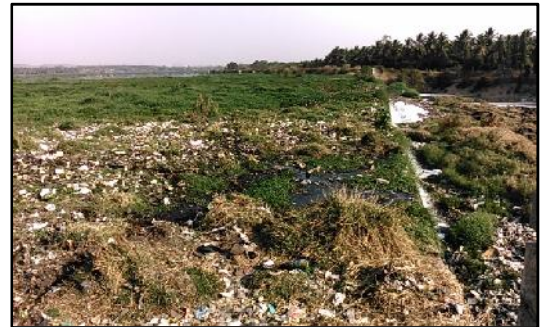
**Aesthetics:** Total maximum daily load to the lake can express the water quality of Byramangala reservoir. High cloudiness of water can significantly reduce the aesthetic quality of reservoir having a harmful impact on recreation. Natural sources can include erosion from upland, riparian, stream bank, and stream channel areas; however, this is difficult to measure due to agriculture and development activity. Human activities can accelerate erosion. Tannic acids often associated with peat and bog areas cause water to be coloured resulting in turbidity.

Figure 8& 9 Unaccountable sewage and impact of eutrophication on the aesthetics of reservoir

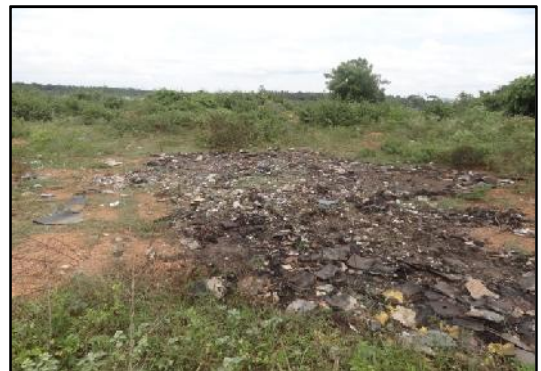
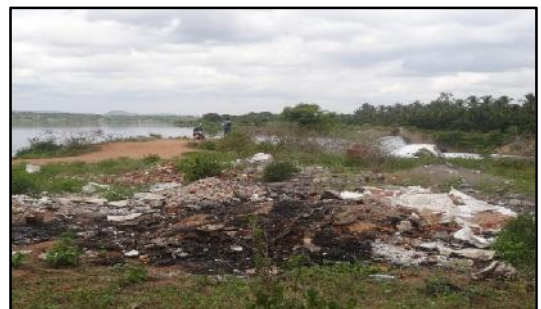
Figure 10&11 Construction waste at the outlet of reservoir

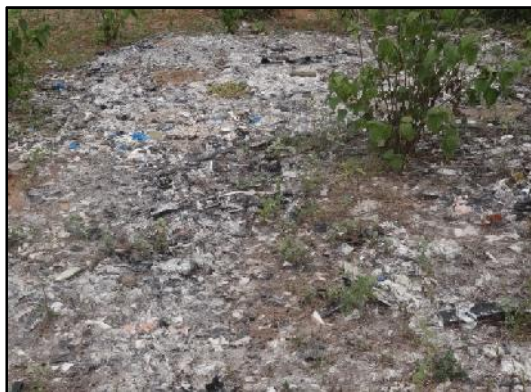
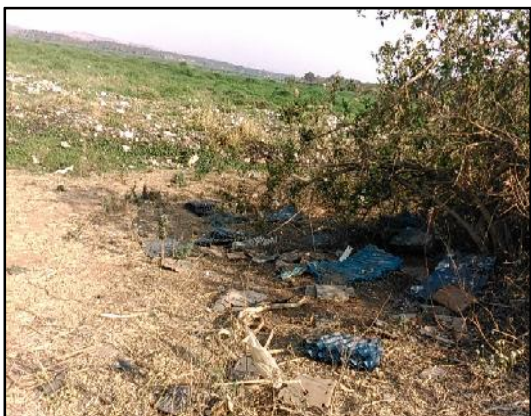
**Figure 12&13** Industrial Fibre wastes dumped on shores of reservoir

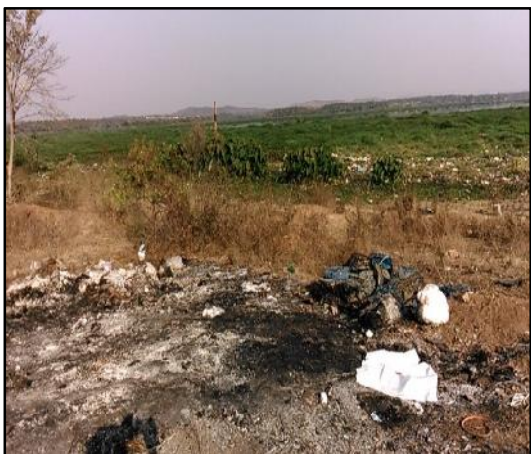
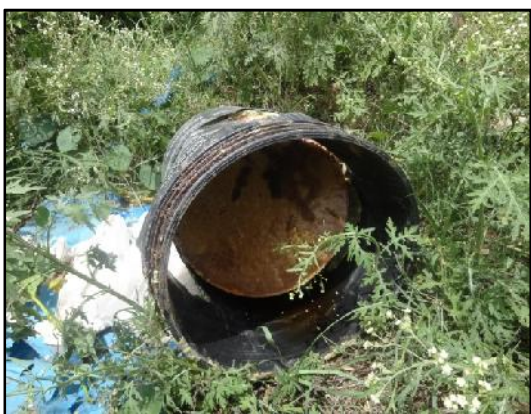
**Figure 14& 15** Chemical wastes dumped at the shores of reservoir

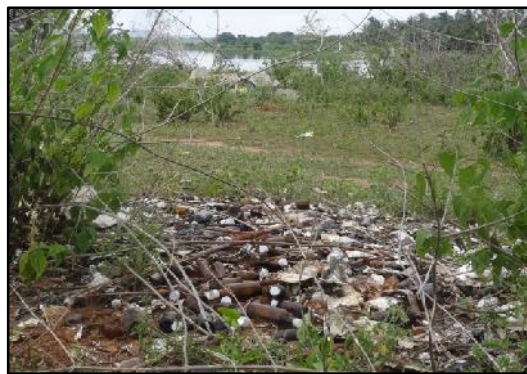
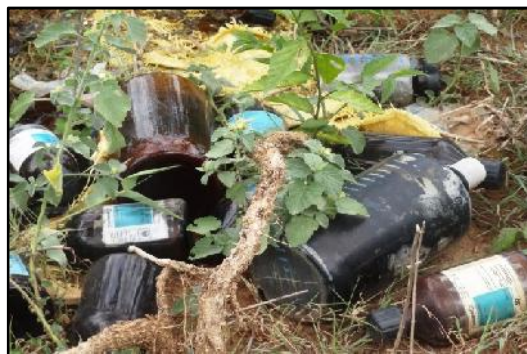
**Figure 16& 17** Laboratory and dispensary glass bottles disposed at the shores of reservoir

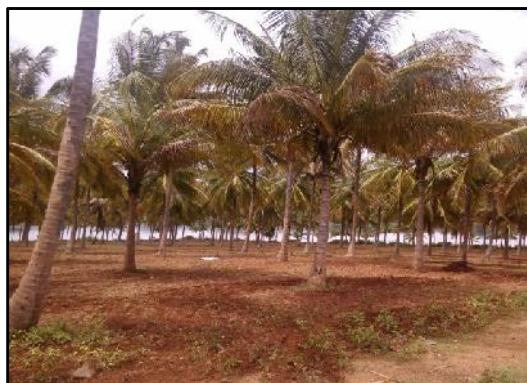
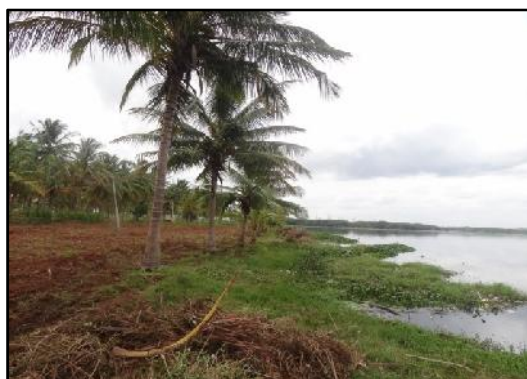
**Non-Point source of pollution:** Enters to the reservoir from a source that cannot be traced to any single site of discharge. Byramangala reservoir is threatened by non-point source of pollution from agricultural field that use chemical fertilizers around the shore clusters as it is revealed when the reservoir water is subjected to physicochemical analysis.

**Figure 18&19** Agriculture expansions and Commercial Plantations in the vicinities of Byramangala reservoir

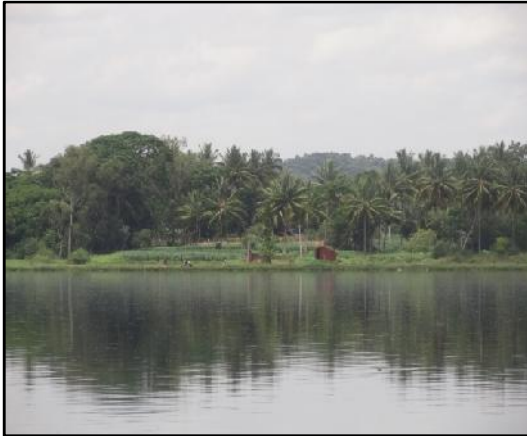
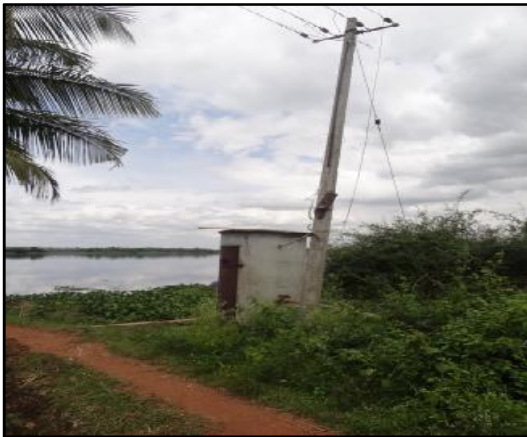
Figure 20& 21 Constructed huts and ground water pump house at shores of reservoir.

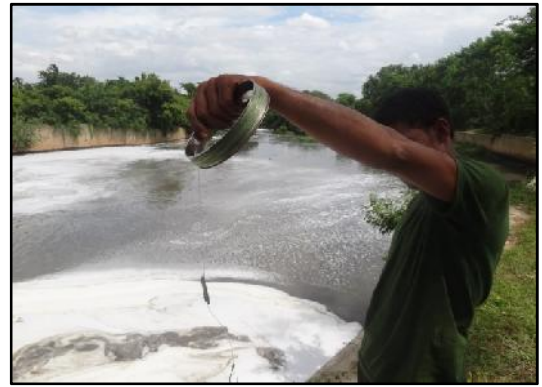
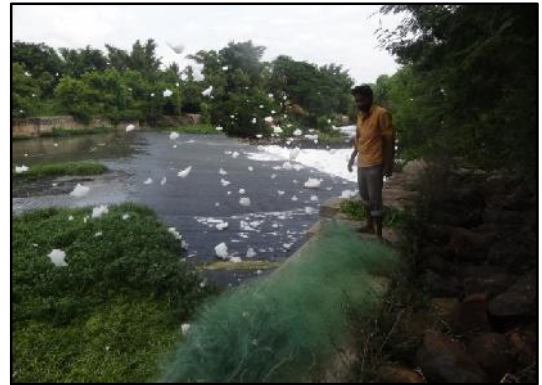
**Fishing, Grazing and Nursery:** Fishing is an enjoyable sport for those looking for outdoor activity, food source as for living communities and more importantly used as commercial purposes. Fishing in this reservoir was undertaken by the Cooperating Society and Department of Fisheries, Karnataka. Due to overload of pollution, fish culture is stopped by the cooperating society.

The Indigenous fishes are taken over by African cat fish. However, in view of the commercial purpose, the fishes were captured and sold by the individuals without any safety plans even though the water is heavily polluted and wastes are accumulated.

Figure 22& 23 Fishing at the weir outlet of the reservoir

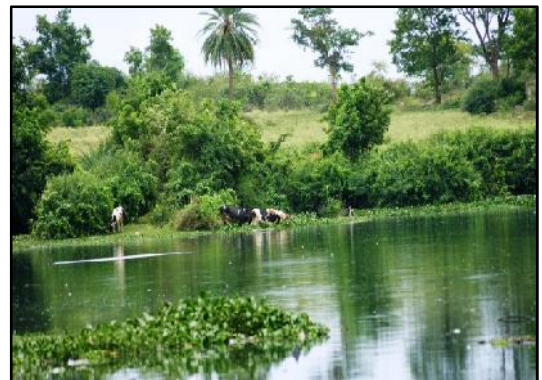
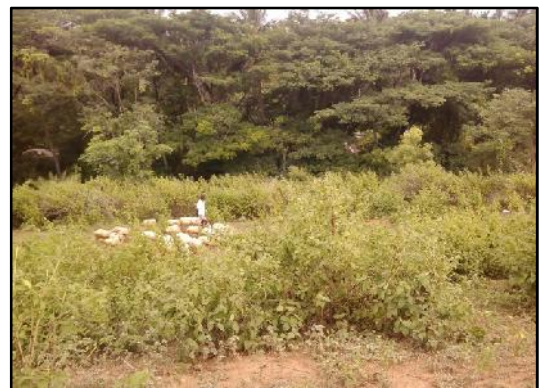
Figure 24&25 Command areas used for animal husbandry and commercial plantations

The command areas are well grown with the nutrient rich water. The commercial crops were grown in the downstream of the lake viz, maize to make the food products, coconut and sapota plantations. The animal husbandry which includes the cattle's and sheep's were also affected by the polluted water.

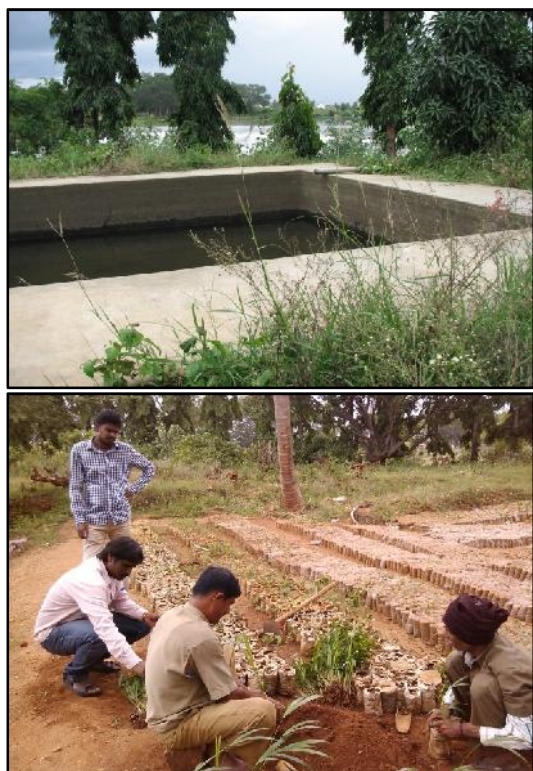
**Figure 26&27** Nursery activities at the outlet of Byramangala reservoir.

In the nurseries, the siblings were formed to plants using this water and the groundwater at the shores of this lake. However, these plats may also affect through the pollution with higher concentrations of heavy metals and damages the resistivity of the plants.
