EVALUATION OF PAVEMENT CONDITION OF RURAL ROADS UNDER PMGSY FOR MAINTENANCE AT PATNA

Suman S.K* and Ajeet KumarYadav

Department of Civil Engineering NIT Patna, Patna-5

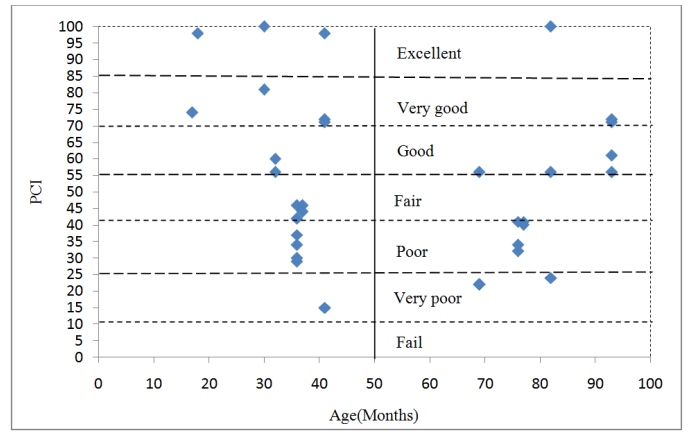
Figure 7 PCI versus age

With reference to Figure 6, it has been observed that 67.57% roads have age around 4 years while 32.43% roads have age more than 4 years. About 35% roads are in serviceable condition whose condition is fair or above otherwise below fair condition. The rate of deterioration is very fast, this may be due to the bad quality of materials, degree of workability, and climatic condition of Patna, Bihar. In Bihar average annual rainfall is 1000mm/year and maximum temperature reached in summer is about 40 °C.
