International Journal of Recent Scientific Research
Vol. 10, Issue, 05(A), pp. 32206-32208, May, 2019

EVALUATION OF DENTINAL DAMAGE CAUSED BY DIFFERENT ROTARY NITI SYSTEMS DURING ROOT CANAL PREPARATION: AN INVITRO STUDY

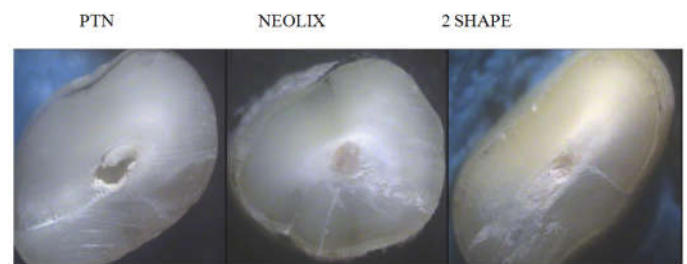
Figure 1 Microcracks in Middle Portion in Different Groups

All specimens were sectioned perpendicular to the long axis at 3, 6 and 9 mm from apex using a low speed saw under water cooling. Slices were observed under stereomicroscope (Wuzhou New Found Instrument Co. Ltd, China) at magnification (10X) and pictures were taken. The images were analyzed using Image analysis software (Chroma Systems Pvt. Ltd, India)

root canal wall of the external surface of the root. ‘Crack’ was defined as all lines, microcracks or fractures observed on the slice that extended from the root canal lumen to the outer surface or from outer root surface into the dentin.
