International Journal of Recent Scientific Research
Vol. 7, Issue, 7, pp. 12427-12430, July, 2016

Case Report

OCCLUSAL STAMP TECHNIQUE FOR DIRECT RESIN COMPOSITE RESTORATION: A CLINICAL CASE REPORT

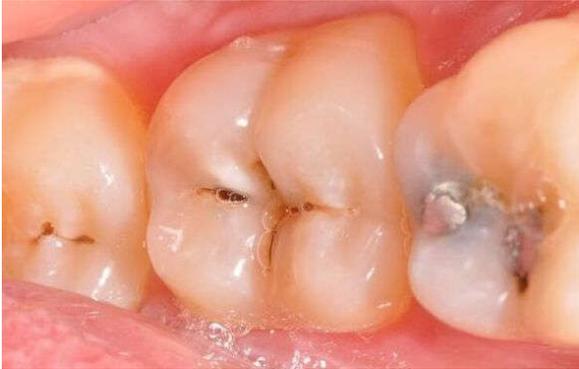
Figure 1. Occlusal aspect of the mandibular left second molar lesion confined to the occlusal surface and with relatively intact enamel.

A 23 years-old man, systemically health, was referred on a dental clinic of the Federal University of Piauí (UFPI), Terezina, Brazil. After completing the required legal and ethical paperwork, the patient was admitted for dental treatment. The clinical examination showed the presence of dark pigments on pits and shading on the surface of the mandibular left second molar, without evidence of cavitation. (Figure 1)

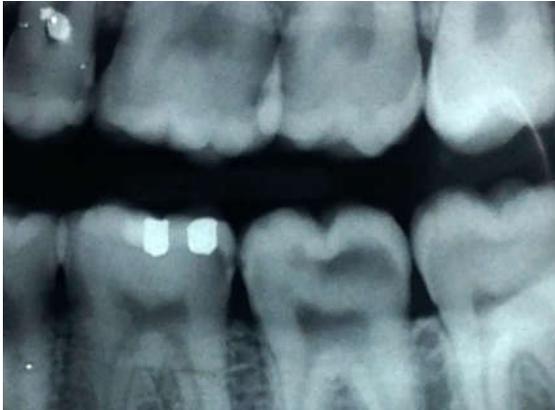
Figure 2. Radiographic appearance of the compromised dentin of the mandibular left second molar.

The patient did not report pain sensitivity in the medical history, but a radiolucent area in the crown of the mandibular left second molar was observed through the interproximal radiographic examination (Figure 2) that suggested the presence of dentin carie lesion with no evidence of pulp involvement. The mandibular left first molar showed dental

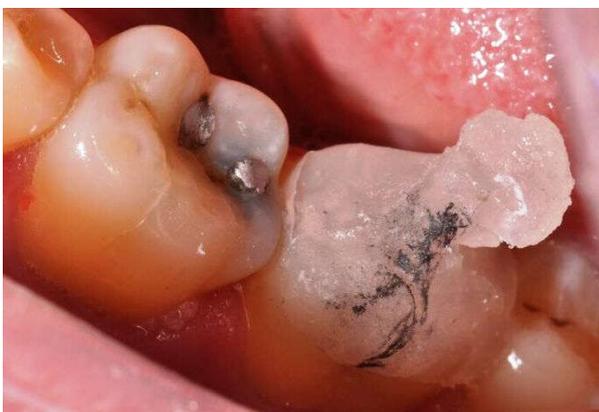
Figure 3. Application under gentle pressure of the occlusal stamp on the occlusal surface of the mandibular left second molar

The clinical-restorative process started by performing the dental prophylaxis with Robson type cleaning brush and pumice to remove the residues on the surface of the tooth and promote a proper color selection through the VITA shade guide. After tooth isolation with vaseline, the stamp was made with transparent heat cure acrylic resin to copy the tooth occlusal details to be restored. The stamp, after its complete curing, was removed and the corresponding edge on the buccal surface of the tooth was marked for orientation at the time of the stamp repositioning. (Figure 3).

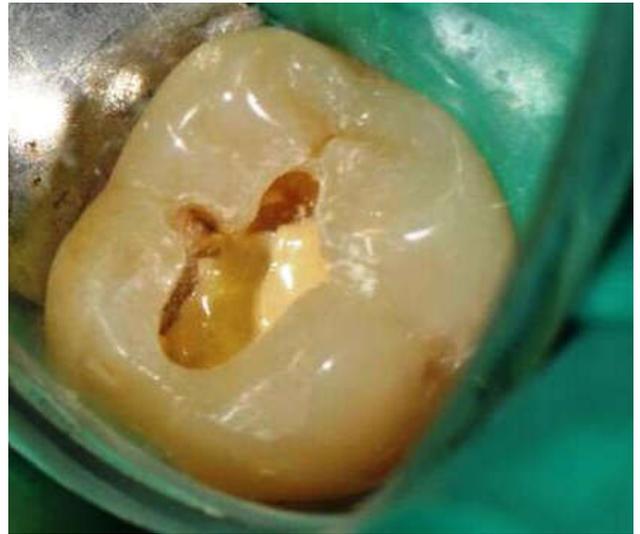
Figure 4. Protection of dentin-pulp complex with calcium hydroxide cement.

After the complete removal of the dental carie, the cavity was rinsed and dentin-pulp complex was protected with calcium hydroxide cement given the depth of the lesion (Figure. 4)

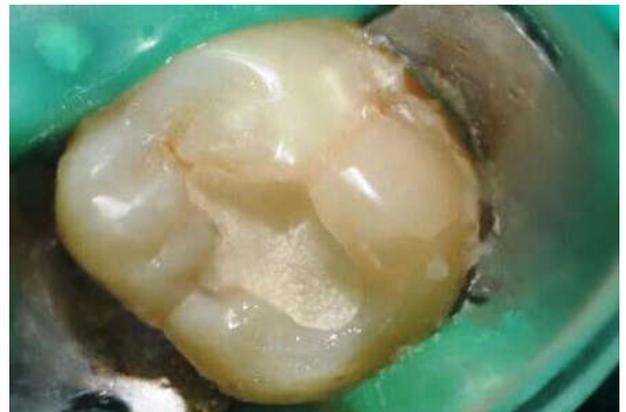
Figure 5. Glass ionomer cement used as a liner (sandwich technique)

Thereafter, the glass ionomer cement - GIC (sandwich technique) was used as a liner, leaving 2 mm for insertion of the resin composite. (Figure 5)

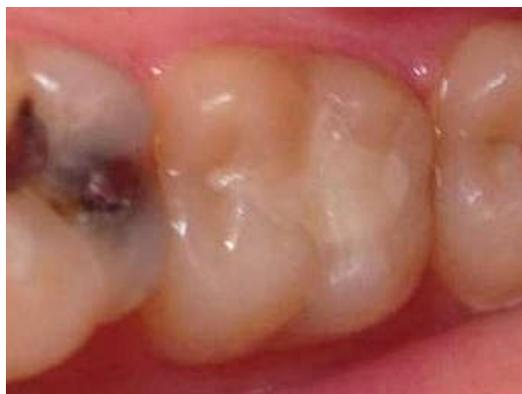
Figure 6. Occlusal aspect of the mandibular left second molar after the resin composite restoration with the stamp technique.

Lastly, after the removal of rubber dam isolation, the occlusal contacts were checked and it was found that there was no need for adjustment (Figure 6). The adaptation was considered satisfactory given the technique used, the stage of finishing and polishing was waived. At a later session, the restorative treatment of the mandibular left first molar was done.
